THERMOGRAPHY REPORT

IR ELECTRICAL SURVEY

***** SAMPLE REPORT *****

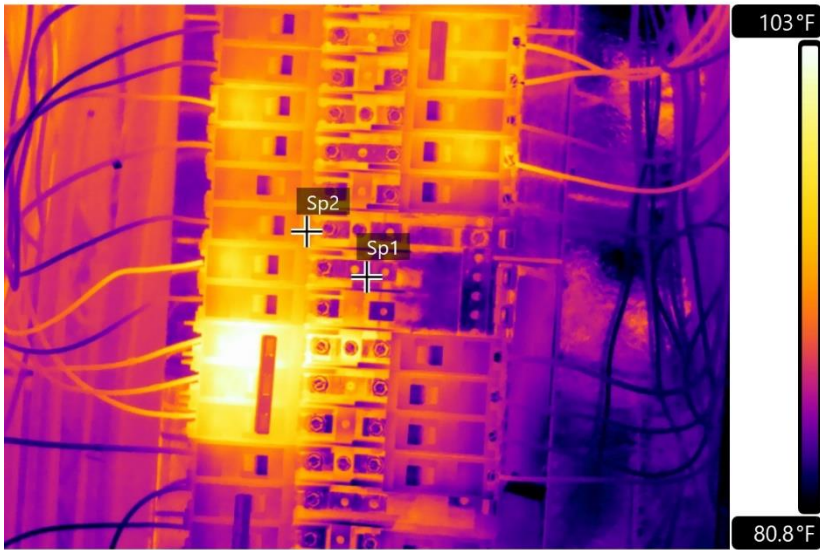
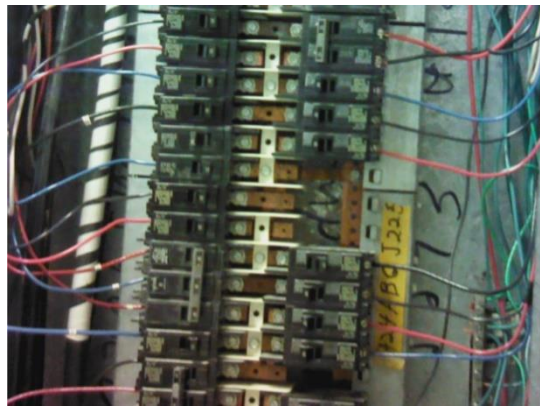
Image Date&Time	3/26/2018 11:15:42 AM
File Name	FLIR1644.jpg
Sp1	86.4 °F
Sp2	90.9 °F
Areas	-
Deltas	-

Location	Elec Rm 1
Equipment	Panel 1
Fault	none
Recommendation	No Repair

No Action.

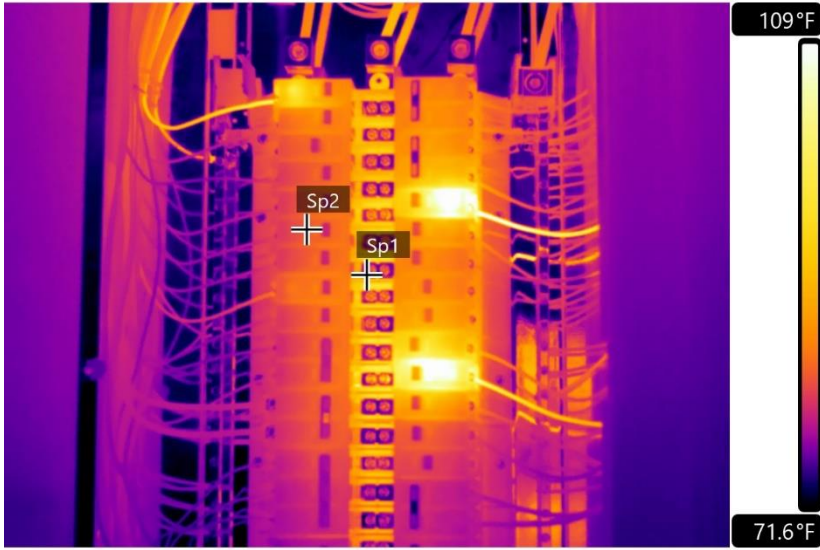
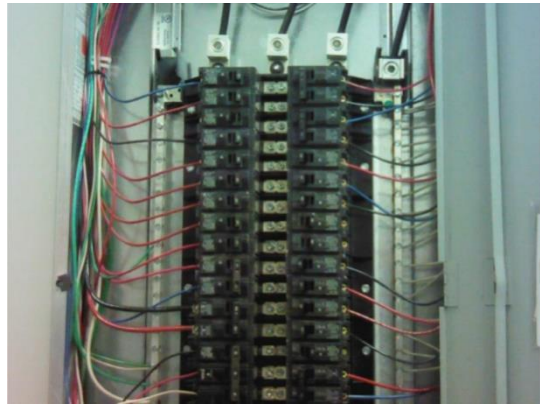
Image Date&Time	3/26/2018 12:24:55 PM
File Name	FLIR1653.jpg
Sp1	77.5 °F
Sp2	82.6 °F
Areas	-
Deltas	-

Location	Elec Rm 3
Equipment	Panel 7
Fault	none
Recommendation	No Repair

No Action.

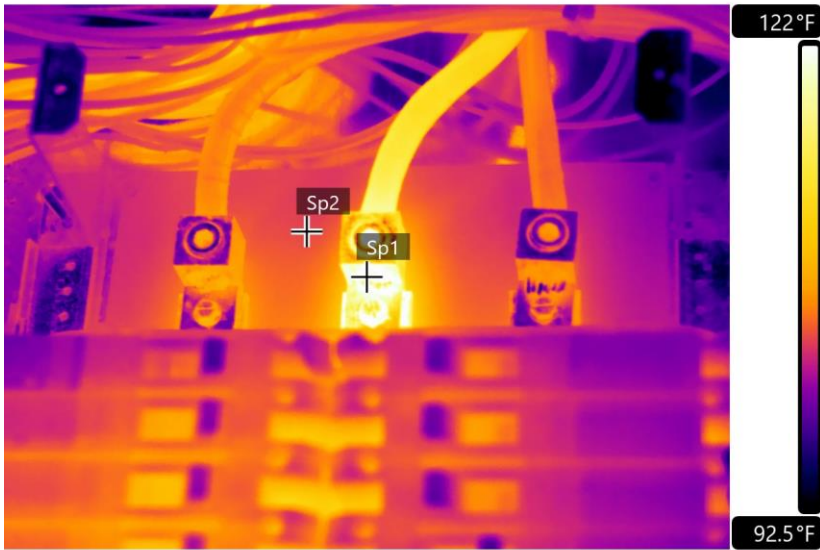
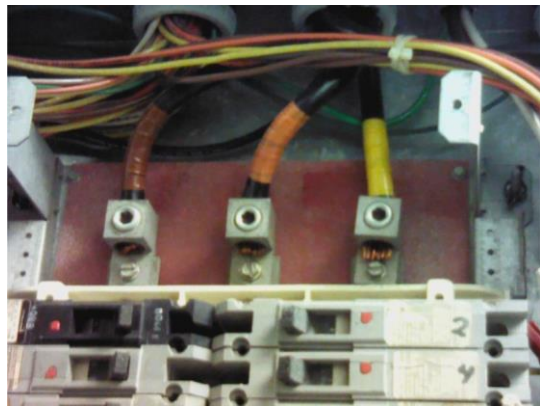
Image Date&Time	3/26/2018 12:43:01 PM
File Name	FLIR1657.jpg
Sp1	122.9 °F
Sp2	104.0 °F
Areas	-
Deltas	-

Location	Elec Rm 2
Equipment	Panel 4
Fault	3 - Repair
Recommendation	Repair

Check and repair phase 2 lug connection to wire.
