#### **OPTICAL GAS IMAGING**

#### SAMPLE VOC REPORT

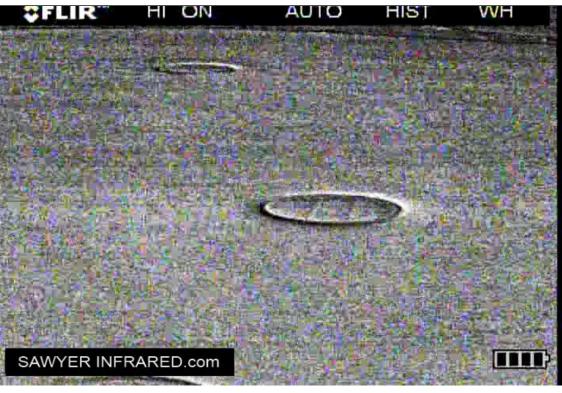
"Proprietary"
Title: MANHOLE VAPOR LEAK

Description: Manhole vapor leak, vapors

**observed** from manhole.

## vapors observed

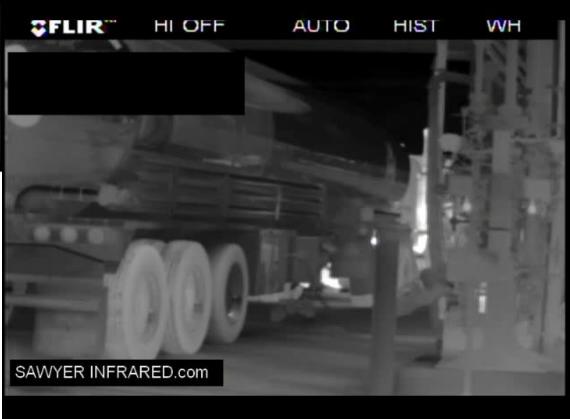
**Title: VAPOR RECOVERY LINE LEAK**

Description: Vapor recovery line leak, vapors

observed at hose connection.

### vapors observed

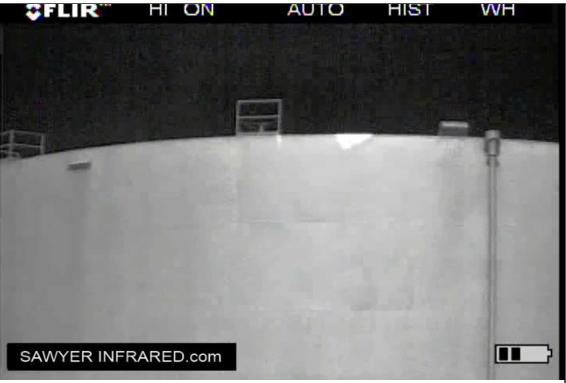
**Title: GASOLINE TANK VENT VAPORS**

Description: Gasoline tank vents, vapors

observed at vents.

# vapors observed

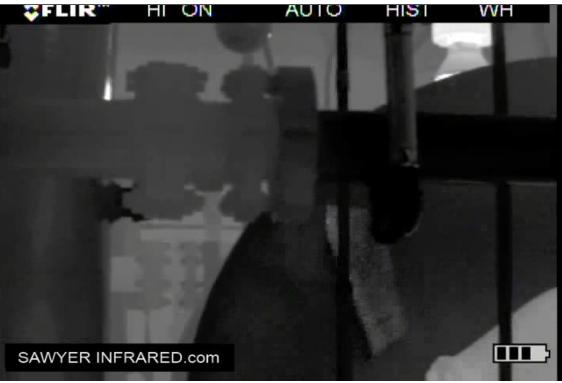
Title: LNG COMPRESSOR FLANGE LEAK

Description: LNG compressor flange leak, vapors observed from compressor flange

weep hole.

### vapors observed

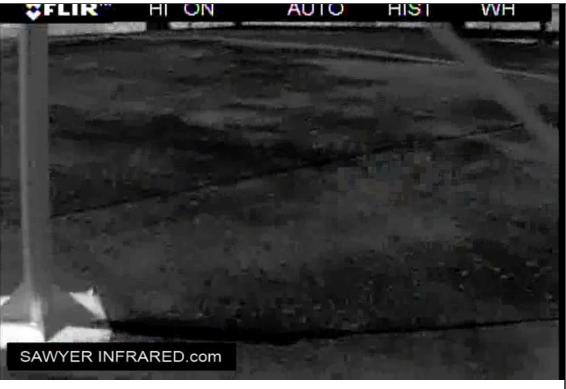
**Title: LNG TANK LEAK**

Description: Top of tank LNG leak, **vapors observed** from a hole at the top of the tank.

### vapors observed

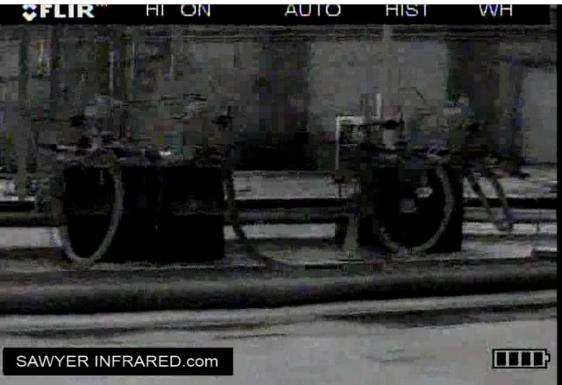
**Title: LNG TRUCK STATION LEAK**

Description: LNG truck station leak, vapors

**observed** from fill hose.

## vapors observed

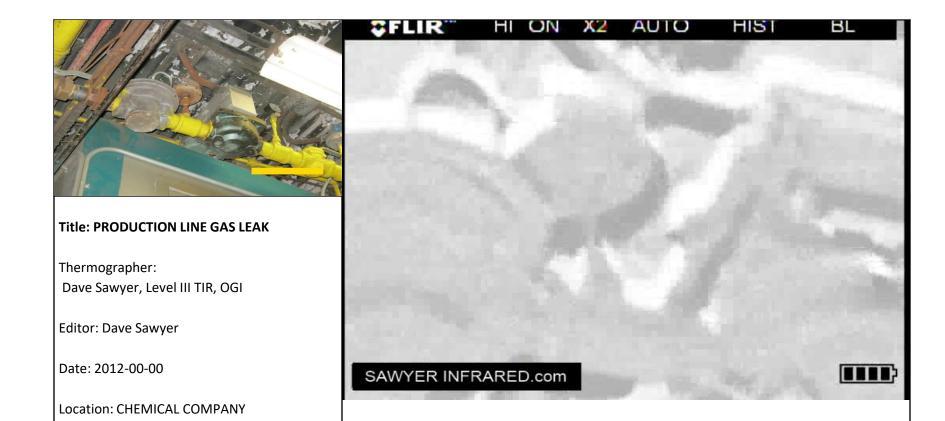
Description: Leak on gas fired production line,

vapors observed at regulator.

## vapors observed

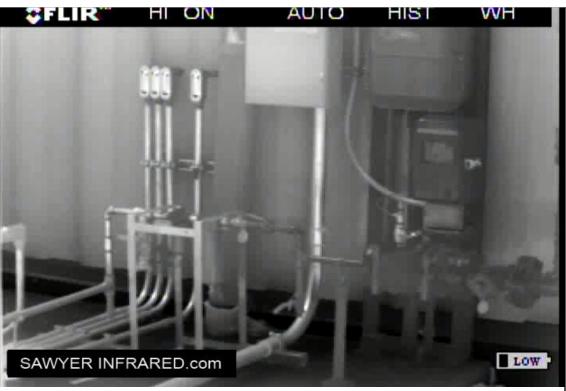
**Title: REGULATOR LINE UNION LEAK**

Description: Regulator line leak, vapors

**observed** at pipe union.

# vapors observed
