Cold Air in Boston: A High-Rise Wants It Out and a Grocery Chain Wants It Kept In

Dave Sawyer
SAWYER INFRARED.com

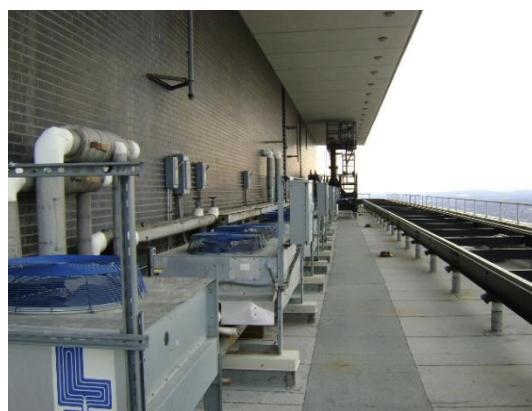
At the 52 story level of this building is a roof level that encircles the main electrical and mechanical floor of this particular building. The window washing machinery of this structure takes up most of this roof level's floor surface. Above this roof level is an overhang extending out to the edge of the building. There are three floors above this overhang section. And, depending upon which side of the four sides of the building that you're standing on it's the windy side that's the scariest to be on. Trust me. It looks something like this.

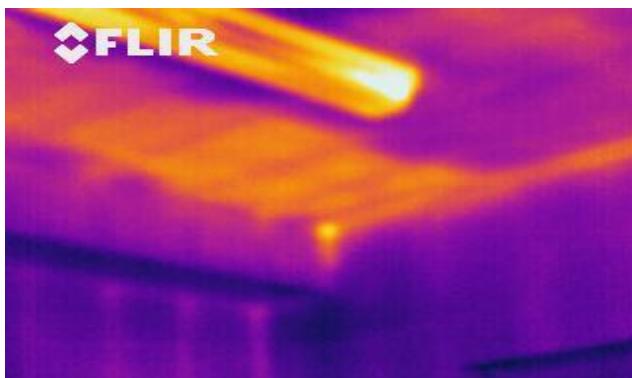
The missing freezer ceiling sections of insulation, from inside the freezers. Yellow areas are voids.
